DTA Culvert
Miller Creek under DTA Bus Garage
Condition Report
December 2019

LHB Project No. 190558.00

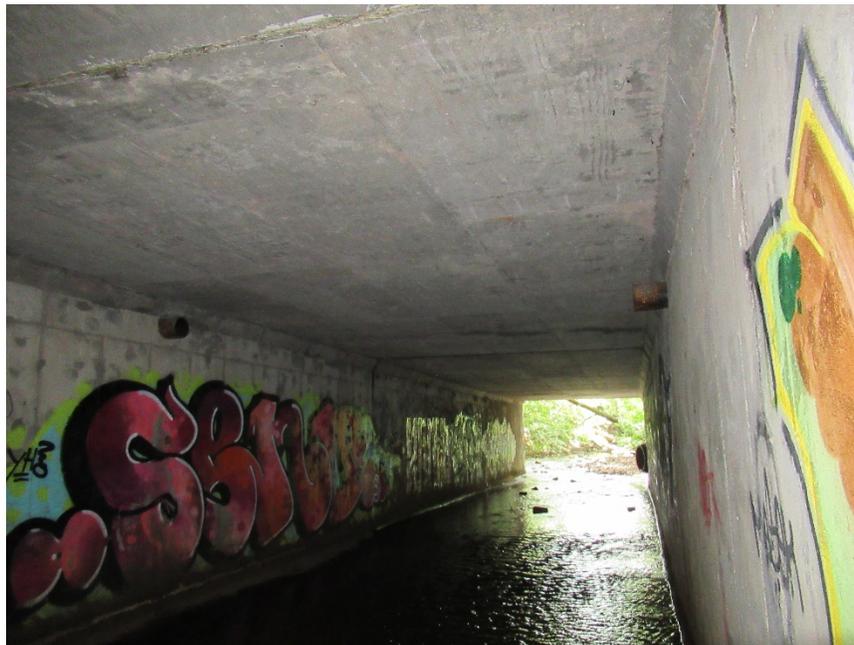
The culvert walls and ceilings are in good condition, with no significant cracking, leaching or efflorescence present (Photo 1, typical condition). There are two locations (Photos 2 & 3) of exposed vertical reinforcing in the culvert walls with minor surface spalling of approximately 1/2-inch-deep and surface corrosion of the reinforcing (no section loss).

Photo 1: Typical Culvert Wall & Ceiling Condition

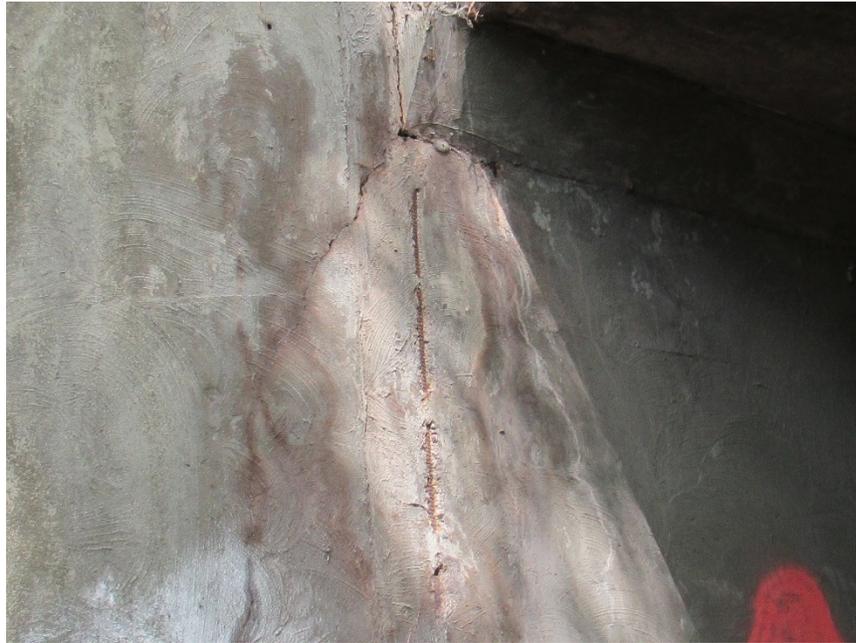
Photo 2: Culvert Section 1 (inlet, north wall) Exposed and Corroding Reinforcement
also note crack in wingwall with rust staining

The surface spalling and reinforcement corrosion is occurring due to the limited cover provided over the reinforcing bar in these isolated regions during construction. This is not currently a critical deficiency, but preventative maintenance could prove to be beneficial. The exposed reinforcement should be cleaned and epoxy-coated to slow future corrosion. This repair should occur in the near term (the next 0-5 years).

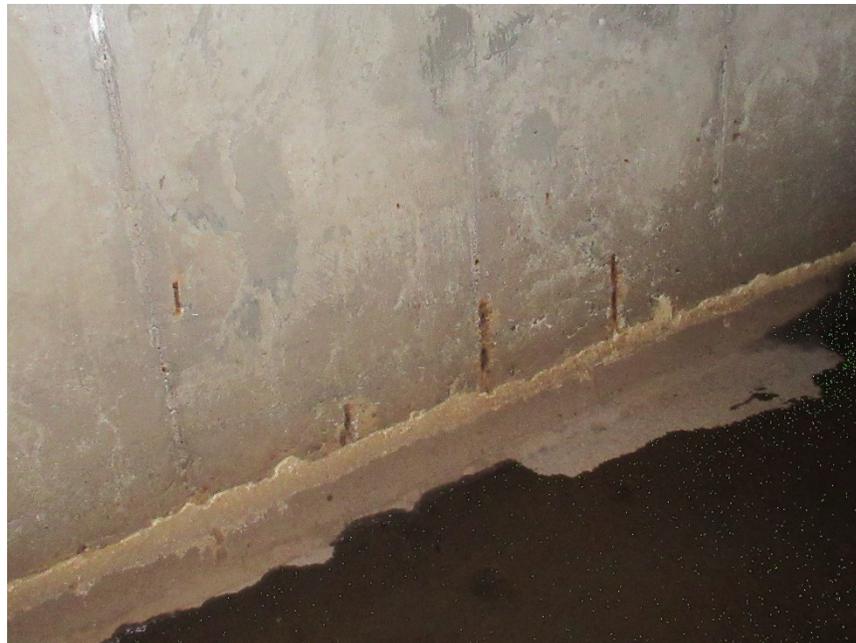
Photo 3: Culvert Section 6 (north wall) Exposed and Corroding Reinforcement

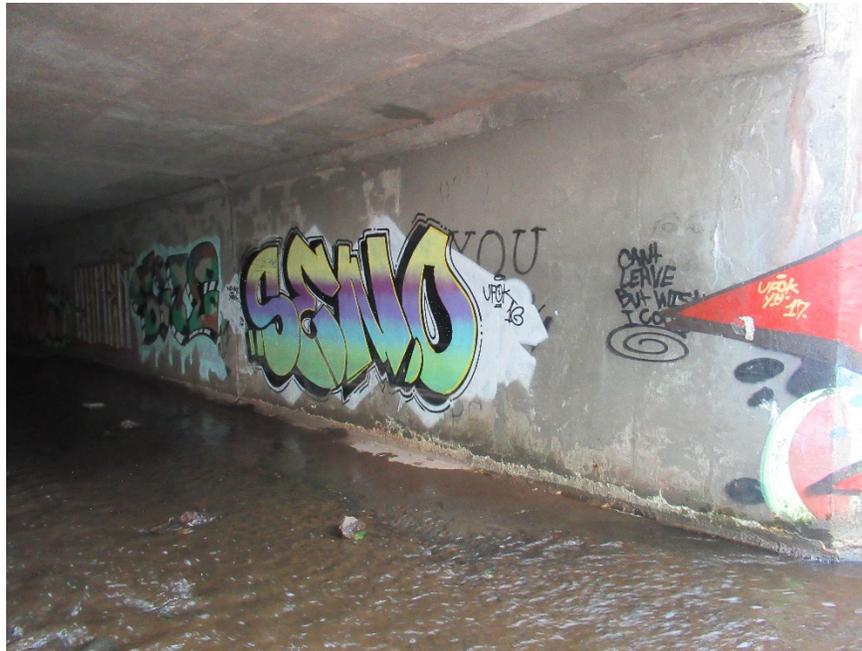
The culvert floor is scoured, especially at the inlet of the culvert. The average scour depth at the inlet is 1 inch over 14 feet of the 16-foot-width (Photo 4). Additionally, at the culvert inlet (segment 1), there is an area of deep scour up to 3 1/2 inches deep with exposed reinforcing. This scour is located beneath the outlet of a storm drainage pipe (30-inch RCP) in the wall of the box culvert (Photo 5). The area of deep scour measures 7 feet long by 2 feet wide. There is exposed reinforcing which has experienced minor loss of steel section.

Photo 4: Culvert Floor Typical Condition
note scour through middle & intact floor at edge

Due to the presence of scour throughout the culvert floor, a larger scale rehabilitation of the culvert should consider placing a new concrete invert throughout the entire floor. This would substantially extend the service life of the structure.

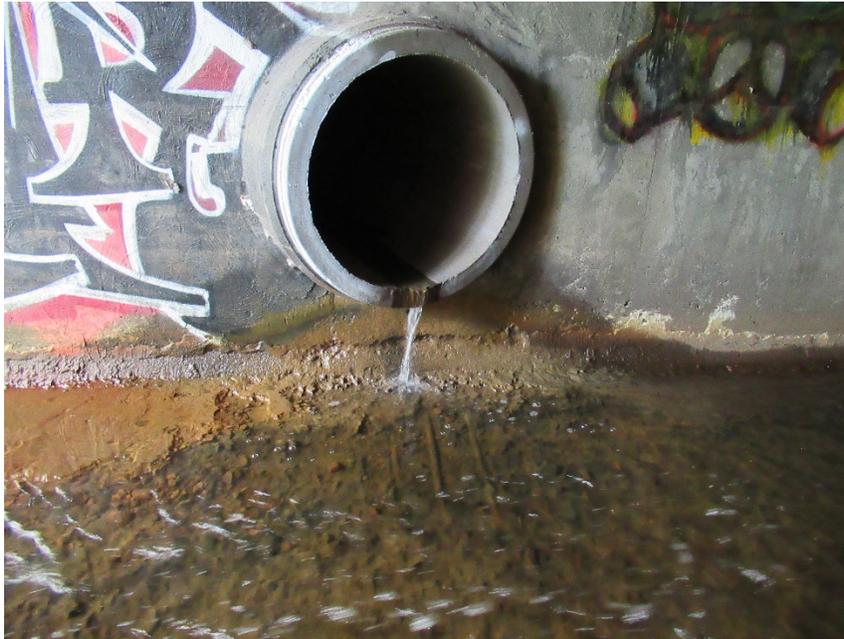
Photo 5: Deep Scour in Floor at RCP Outlet near Inlet of Culvert
note exposed reinforcing in floor

Repair to the floor would require dewatering of the floor to allow for the repair work to be completed in the dry. Temporary plugging or diverting of the storm drainage pipe would also be required to ensure the repair area remains dry. The concrete around the exposed reinforcing should be removed in order to anchor the new patch concrete to the existing concrete. This repair should be considered in the next 5 years. Prior to repair, the condition of the concrete and reinforcing should be monitored on an annual basis to ensure loss of concrete or steel reinforcing section is not occurring at an accelerated rate.

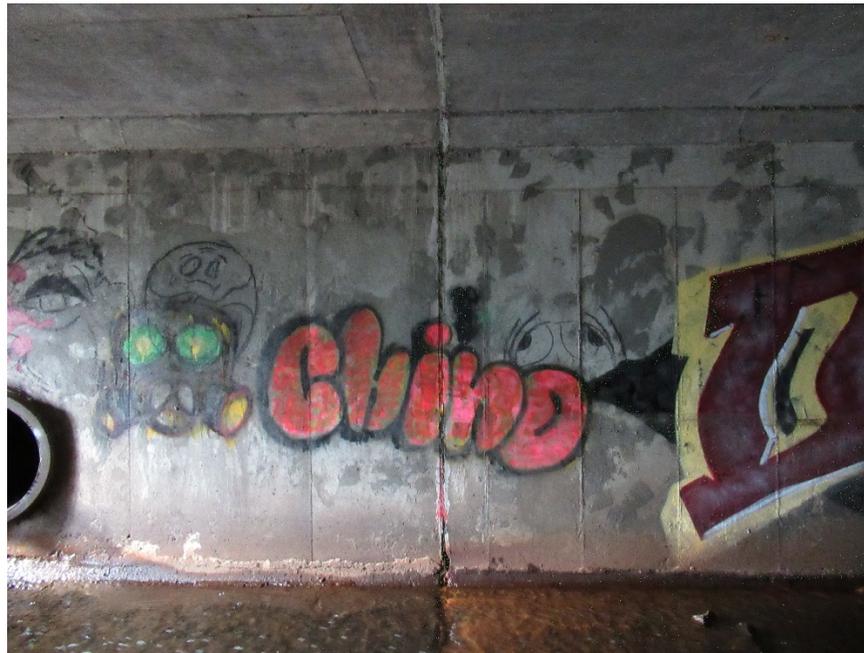
There are joints between each of the 18 box culvert segments (17 joints total). See Photo 6 for typical joint. The lower region of the joints (floor joints) is composed of a 1 1/2" polystyrene (styrofoam) joint filler with a hot-pour tar applied over the filler. The floor joints consist of the horizontal floor joint as well as 4-to-8 inches up the wall joints. The remainder of the wall joints and the ceiling joints also have a styrofoam joint with the interior surface filled with backer rod and sealant. See Photo 7 for lower joint configuration.

Photo 6: Typical Joint between Box Culvert Segments
joint 2 (north) pictured

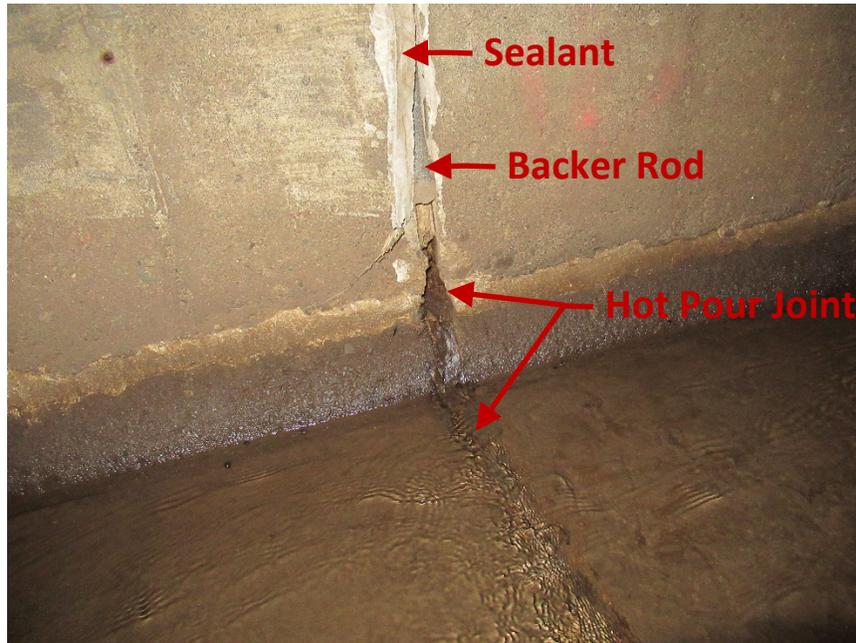
Photo 7: Typical Joint Condition
joint 7 pictured

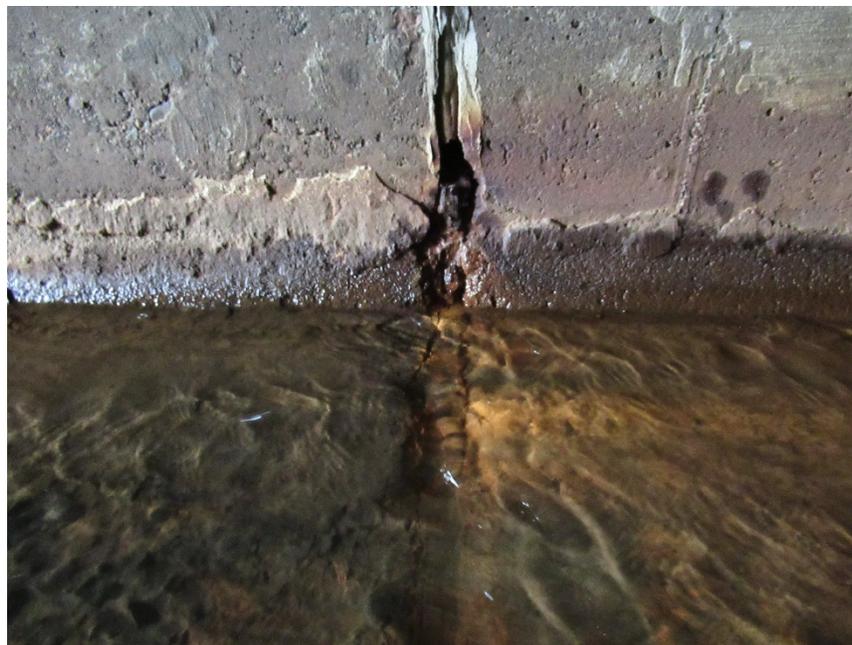
Photo 8: Typical Deteriorated Floor Joint
joint 2 pictured

The hot pour surface of the horizontal portion of the floor joints has failed for the full length of the joint with the polystyrene deteriorated or missing up to 4" beneath the existing floor surface. The majority of the joint filler in the lower 8" of the walls is missing with some locations where the joint filler is intact but in a deteriorated state. See Photo 8 for a typical deteriorated floor joint. The backer rod and sealant in the walls is generally cracked and/or separated from the concrete with the backer rod still present in the joints. Along the ceiling joint the sealant is generally intact with some areas of cracked or separated sealant. The wall and ceiling joints have been resealed though previous maintenance projects. There is no evidence of moisture or fill leaching through the wall or ceiling joints.

Although the hot pour joints are failing, there is no evidence of loss of material/fill through the joints. Immediate repair of the joints is not required. However, with a future comprehensive rehabilitation where a new concrete floor invert is placed, the joints would be cleaned out and filled and control joints would be perpetuated though the new slab. Following floor invert replacement, the backer rods and sealant in walls and ceiling joints could be removed and replaced, however the function of this interior sealing is unknown and may not be required for long term serviceability of the culvert.

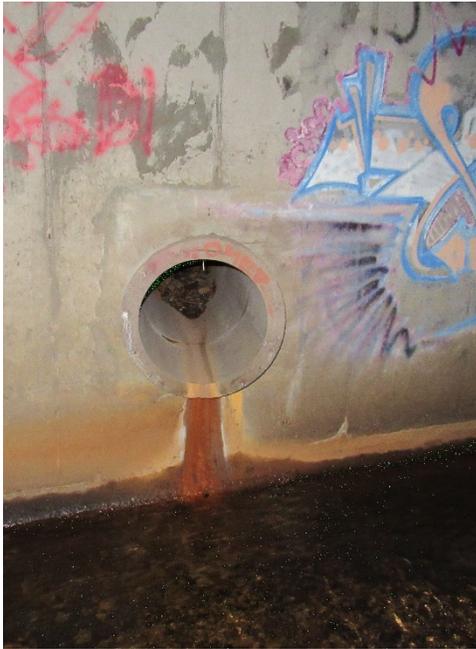
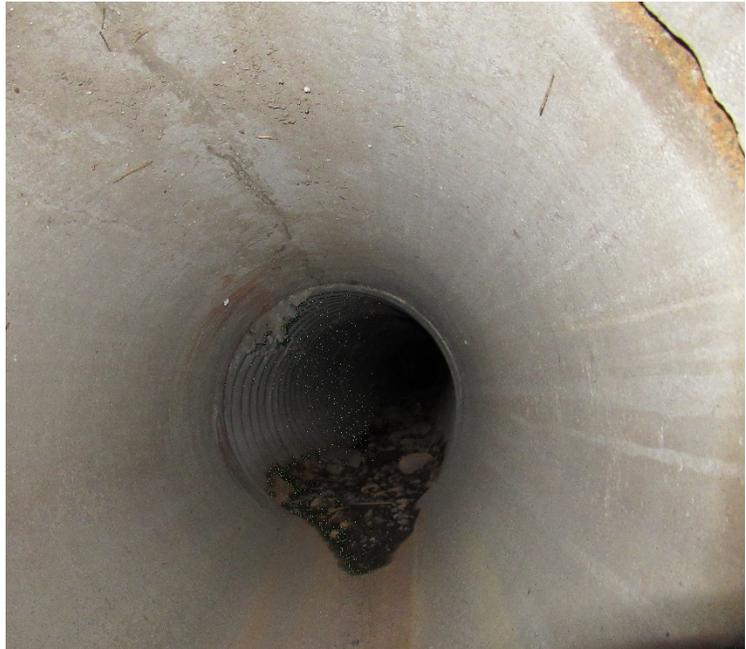
The 30-inch RCP is in good condition. The 18-inch RCP transitions into an 18-inch corrugated metal pipe (CMP) after the second pipe segment. There is rust staining at the outlet of the pipe indicating likely corrosion of the CMP invert. The lower portion of the CMP was filled with gravel. The 24" RCP is disjointed between the first and second pipe segments, approximately 2.5 feet from the wall face.

Photos 9/10: 18" RCP Storm Inlet - *segment 15, south wall*

No repair is recommended for the 30-inch RCP. The condition of the invert of the 18-inch CMP should be investigated to determine if there is section loss. Severe sections loss may require replacement or re-lining of this pipe. The 24-inch RCP is disjointed. As a temporary repair, the pipe inverts could be cleaned and hand-patched with mortar or grout to prevent water from flowing through the disjointed joint and causing scour of the fill on the exterior of the pipe. A long-term repair would consist of excavation, removal, and replacement of this pipe.

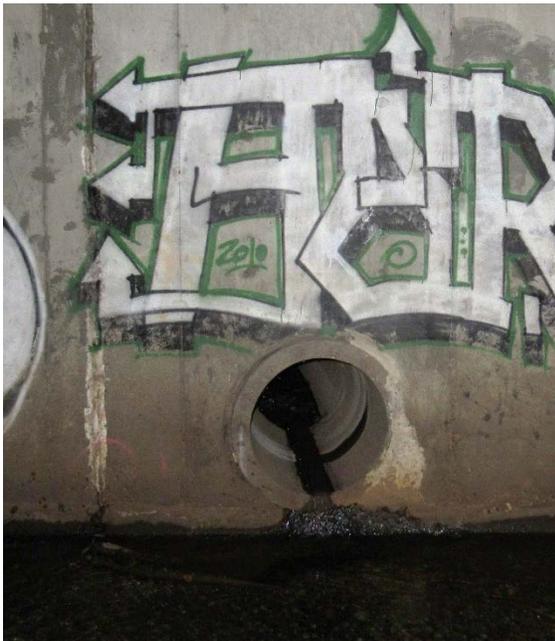
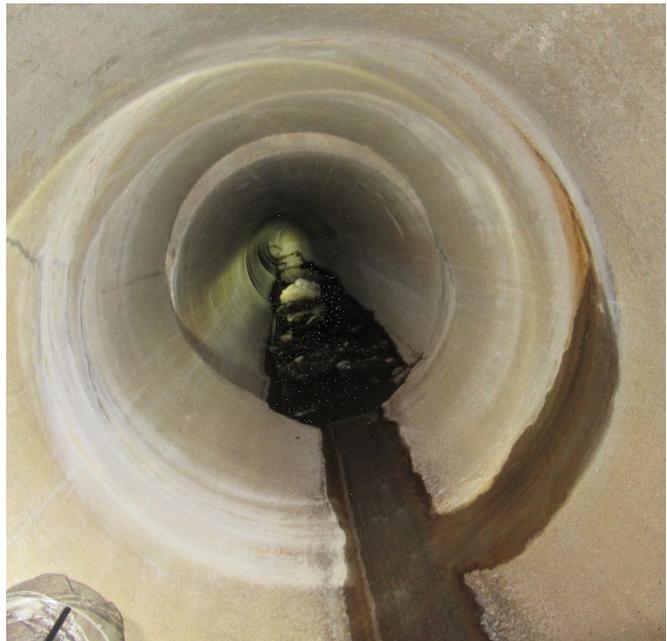
Photos 11/12: 24" RCP Storm Inlet - *segment 17, north wall*

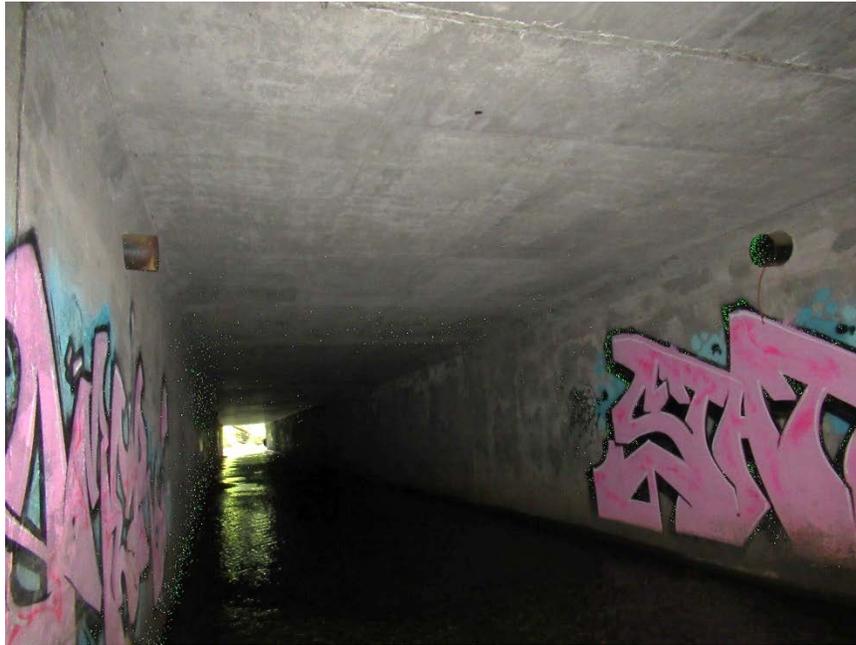
Photo 13: 8" Metal Drain Pipes

The metal drain pipes have active corrosion on the pipe ends (interior and exterior). Rust staining was not observed beneath the pipes. It is unclear whether the pipes are active or not.

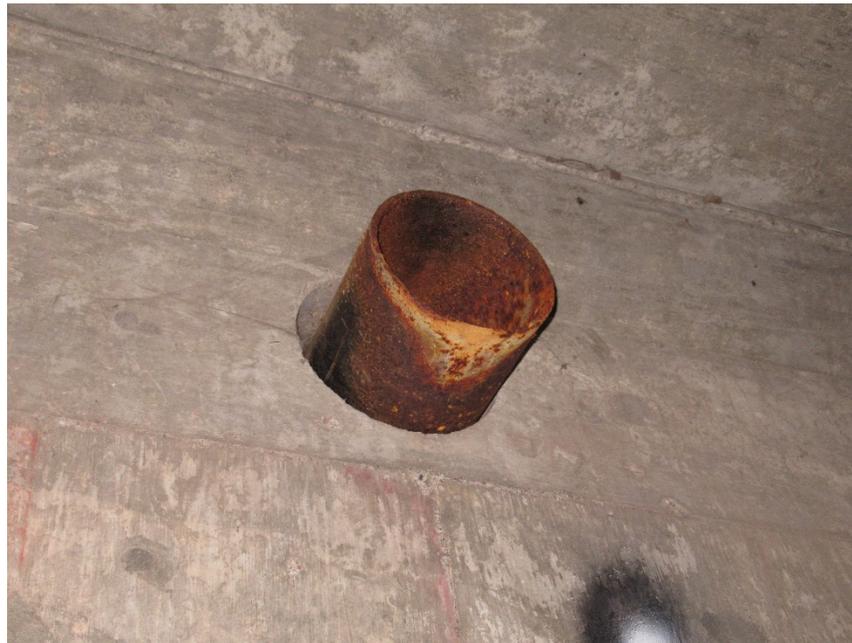
Photo 14: 8" Metal Drain Pipe Corrosion

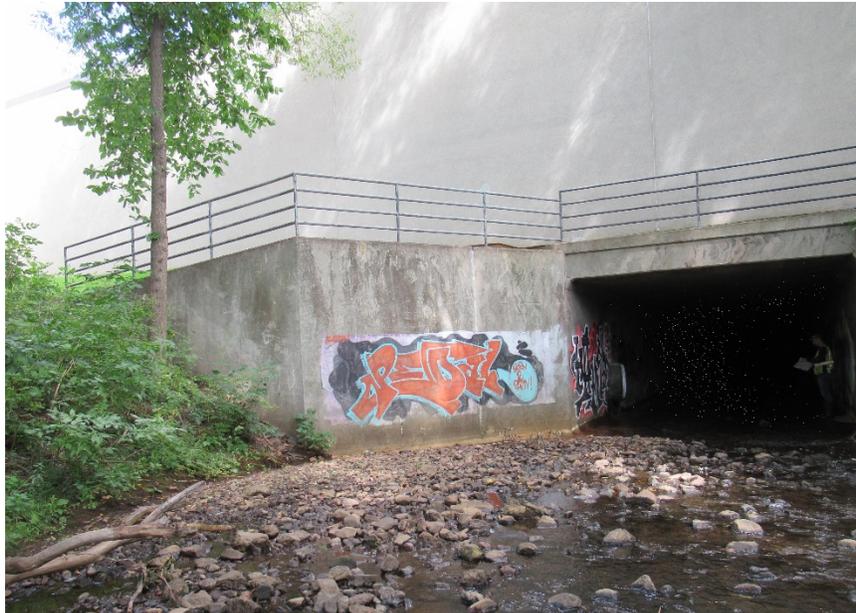
Photo 15: Northwest Wingwall

The inlet and outlet headwall and wingwall concrete is in good condition with no major deterioration. There is a vertical crack with rust staining near the culvert at the tops of both the northwest and southwest wingwalls (see Photo 1).

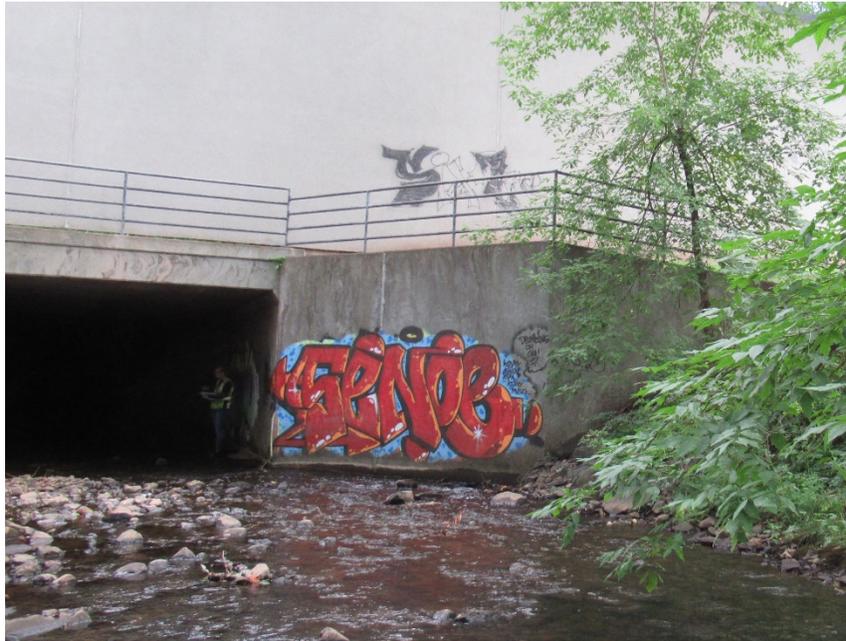
Photo 16: Southwest Wingwall

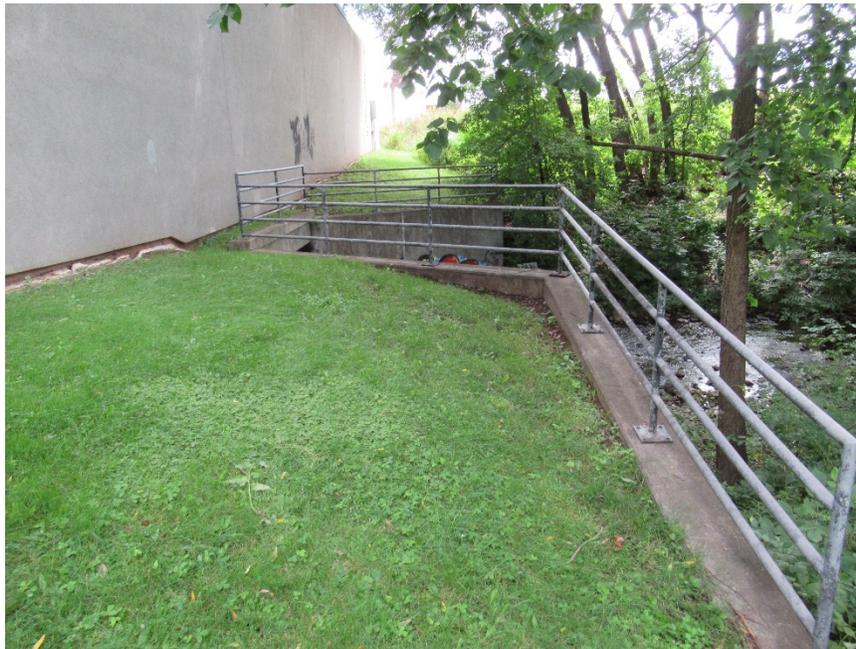
Photo 17: Inlet Headwall/Wingwall Metal Railing

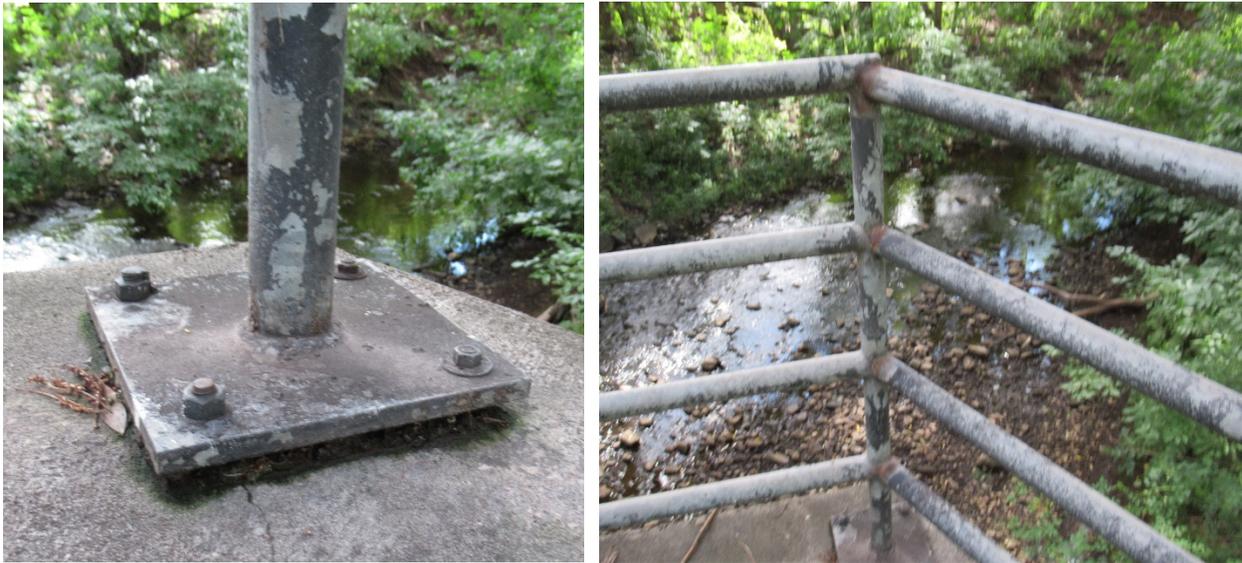
Photo 18/19: Railing Base Plate & Coating Condition

The metal railing and base plates are in similar condition at both the inlet and the outlet. The grout beneath the base plates has deteriorated and/or is missing. And, the top coat of the railing has failed (Photo 18). The galvanized coating is largely intact with some areas of surface corrosion at the welded interfaces of the railing (Photo 19). The limb of a tree is growing through the railing of the northeast wingwall which has caused a portion of the railing to break (Photo 21).

The tree growing through the northeast wingwall railing should be removed and the railing section repaired. In a comprehensive rehabilitation project, the railing should be removed, re-galvanized and re-set. No repairs to the concrete wingwalls and headwall are recommended at this time.

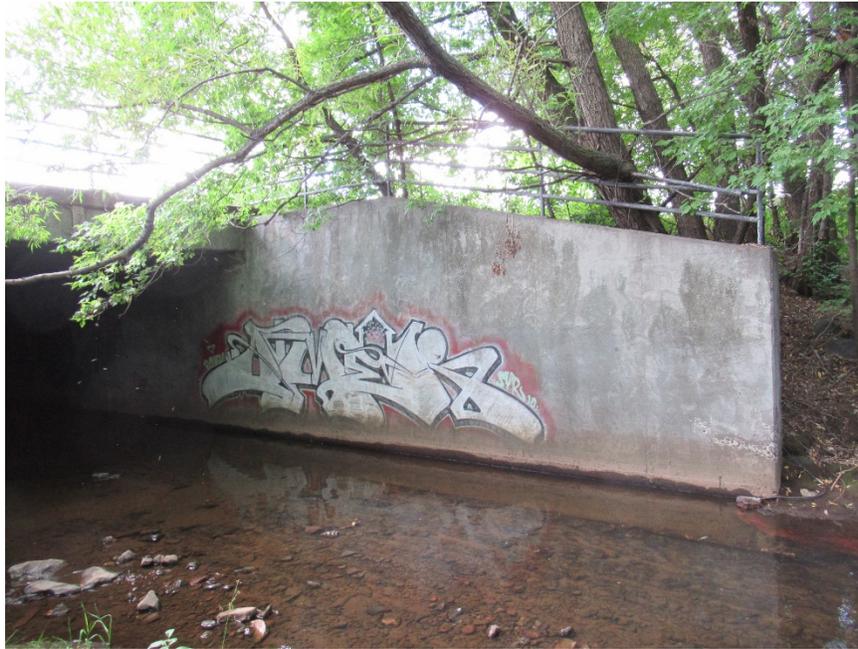
Photo 21: Northeast Wingwall
Note tree through railing and no turn on this wall

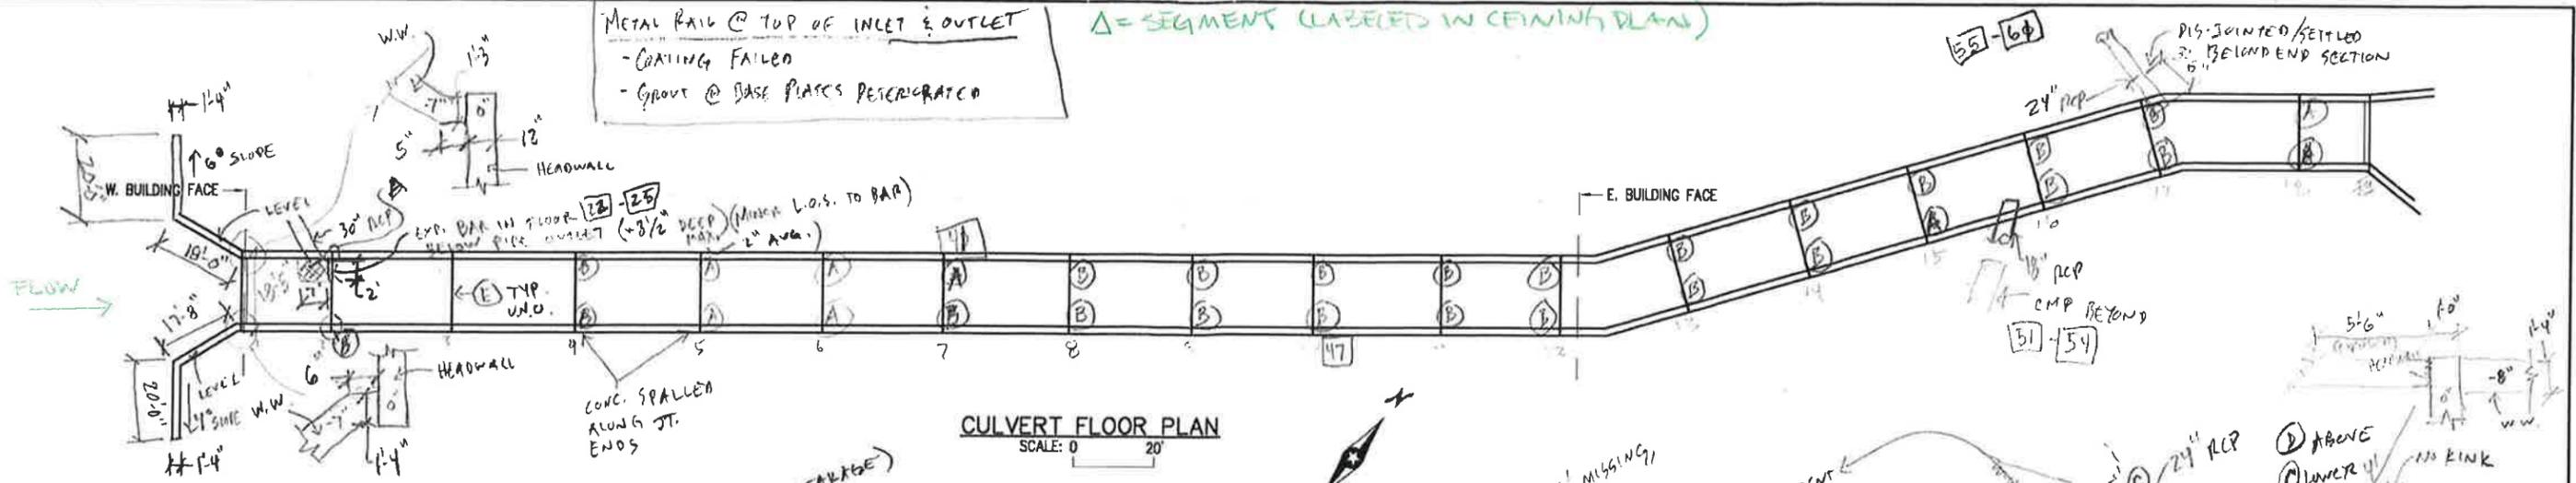
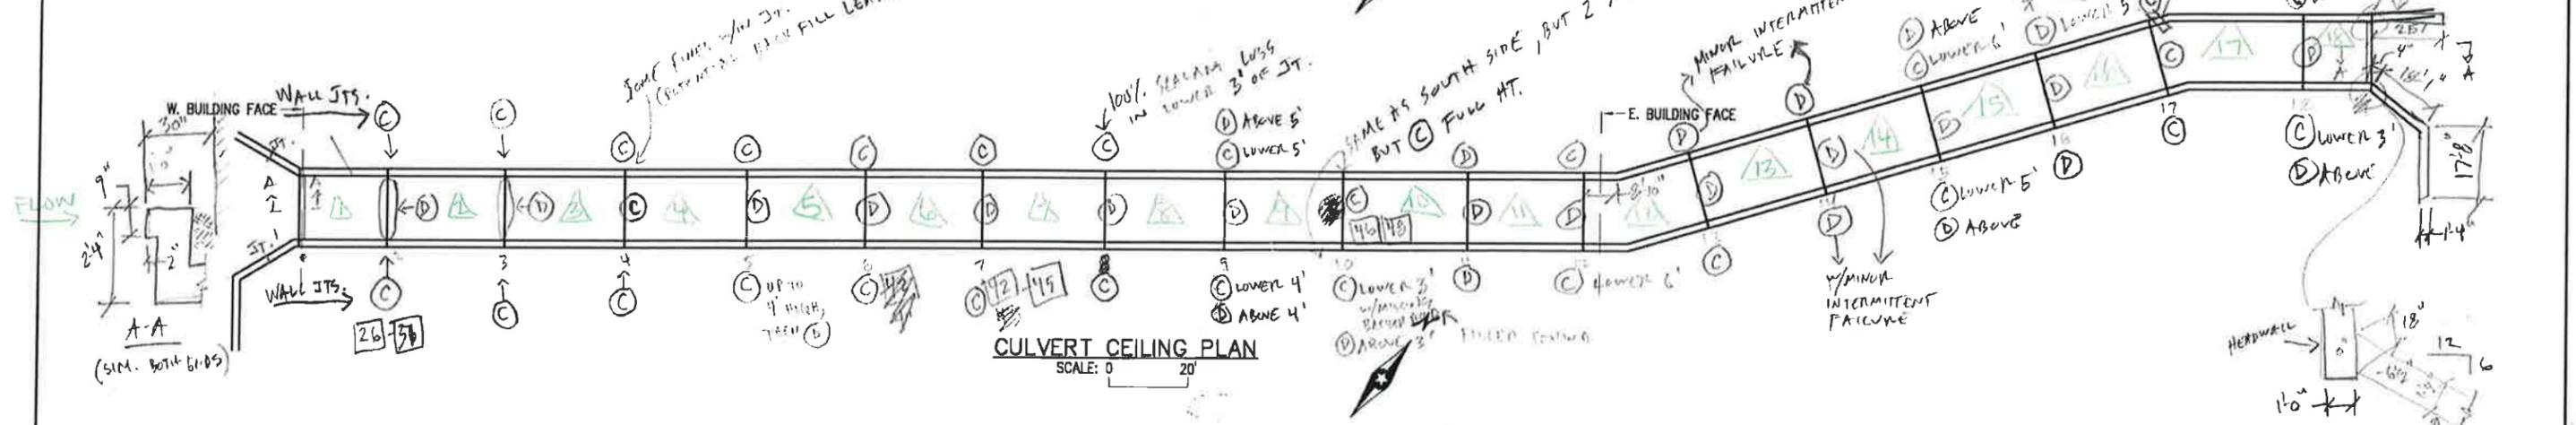
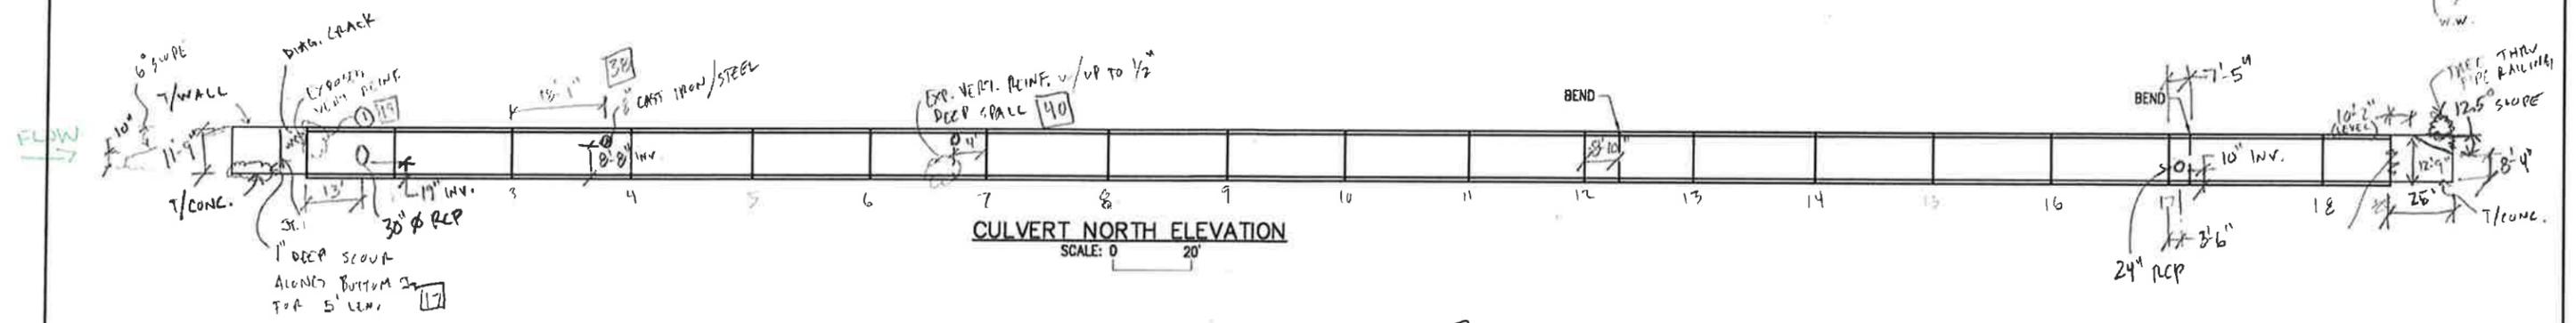
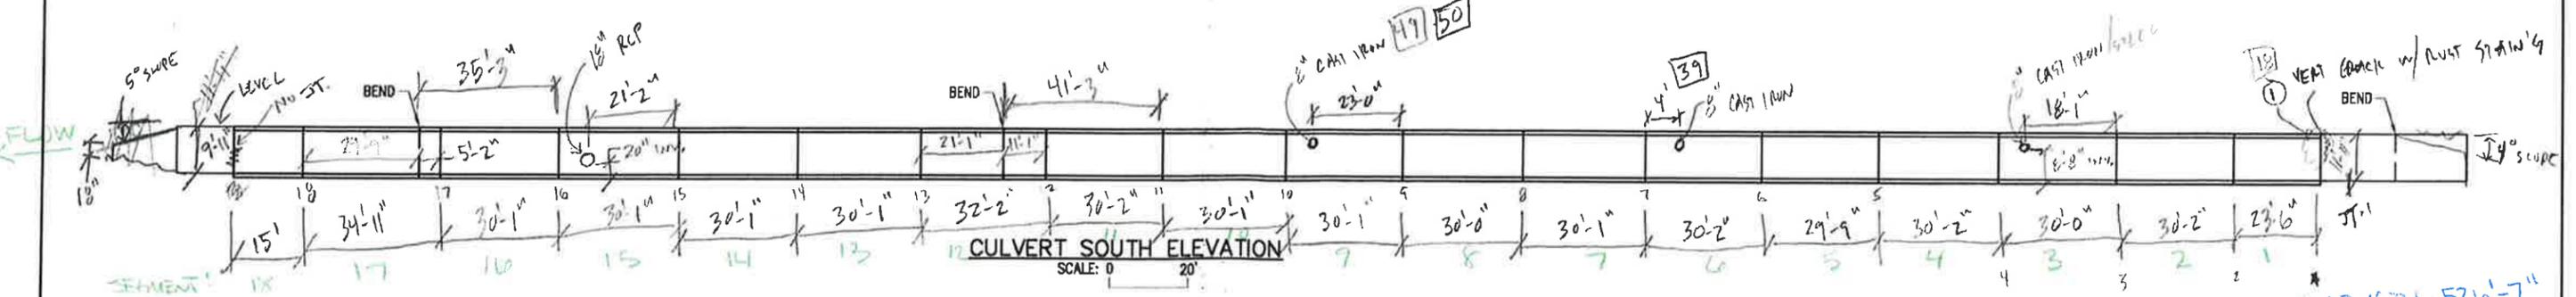
TITLE: INSPECTION SHEET KDM/LMK 9/4/19

METAL RAIL @ TOP OF INLET & OUTLET
 - COATING FAILED
 - GROUT @ BASE PLATES DEGRADED

- B - (A) ~~SEALANT~~ JT. FILLER MISSING UP TO 6" ABOVE FLOOR
- A - (B) ~~SEALANT~~ JT. INTACT BUT DETERIORATED ~~SEALANT~~ @ SEALANT INTERFACES (HOT POUR TO BACKER ROD)
- (C) SEALANT CRACKED &/OR PEELING FROM CONCRETE (FAILED) w/ BACKER ROD PRESENT
- (D) SEALANT & BACKER ROD INTACT & APPEAR TO BE IN GOOD COND.
- (E) HOT POUR ~~SEALANT~~ NEAR OR 100% FAILED FOR FULL LENGTH w/ POLYURETHANE DETERIORATED/MISSING UP TO 4" OR MORE BELOW EXISTING FLOOR SURFACE.
