Main Bus Entry, spalled concrete, recoating

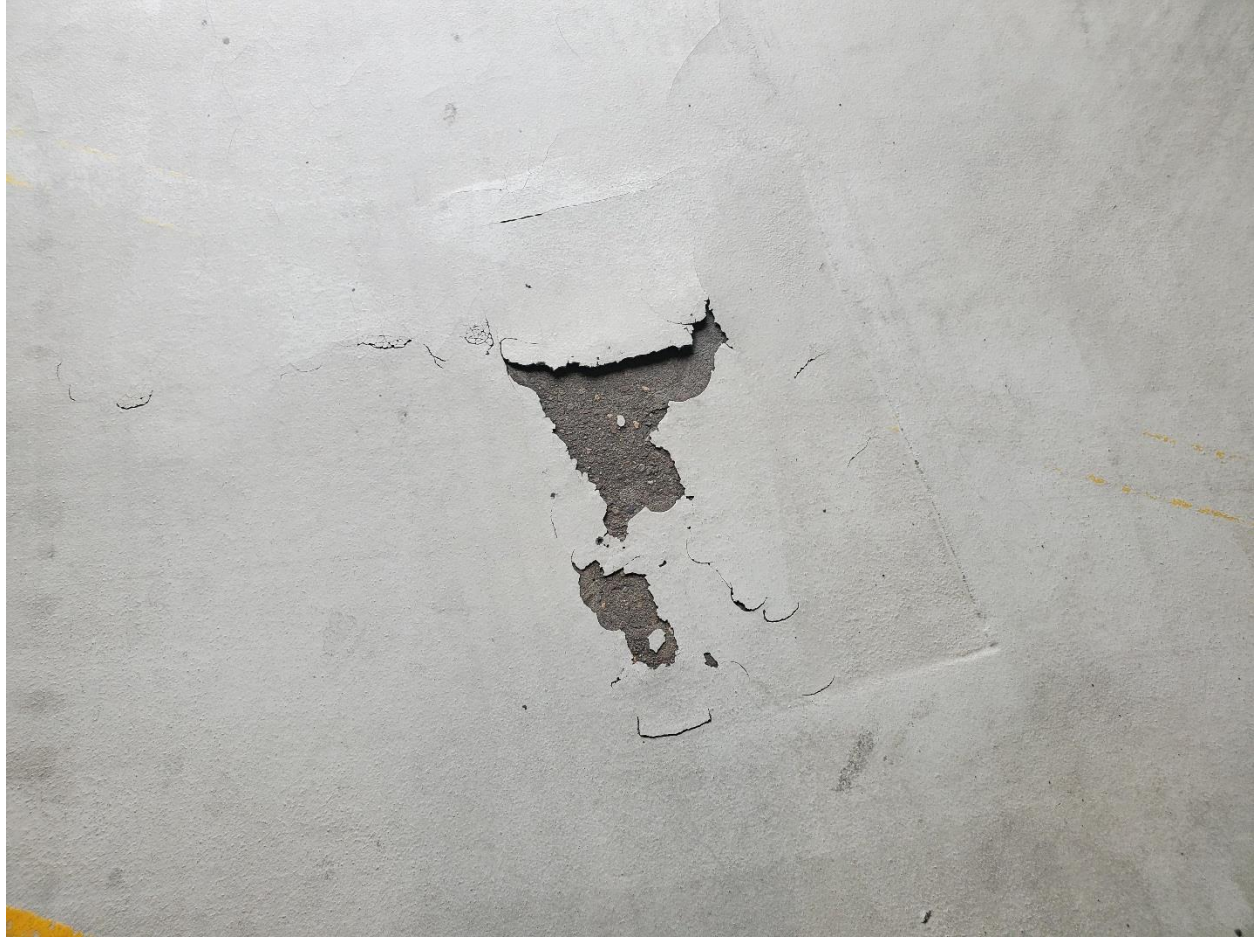
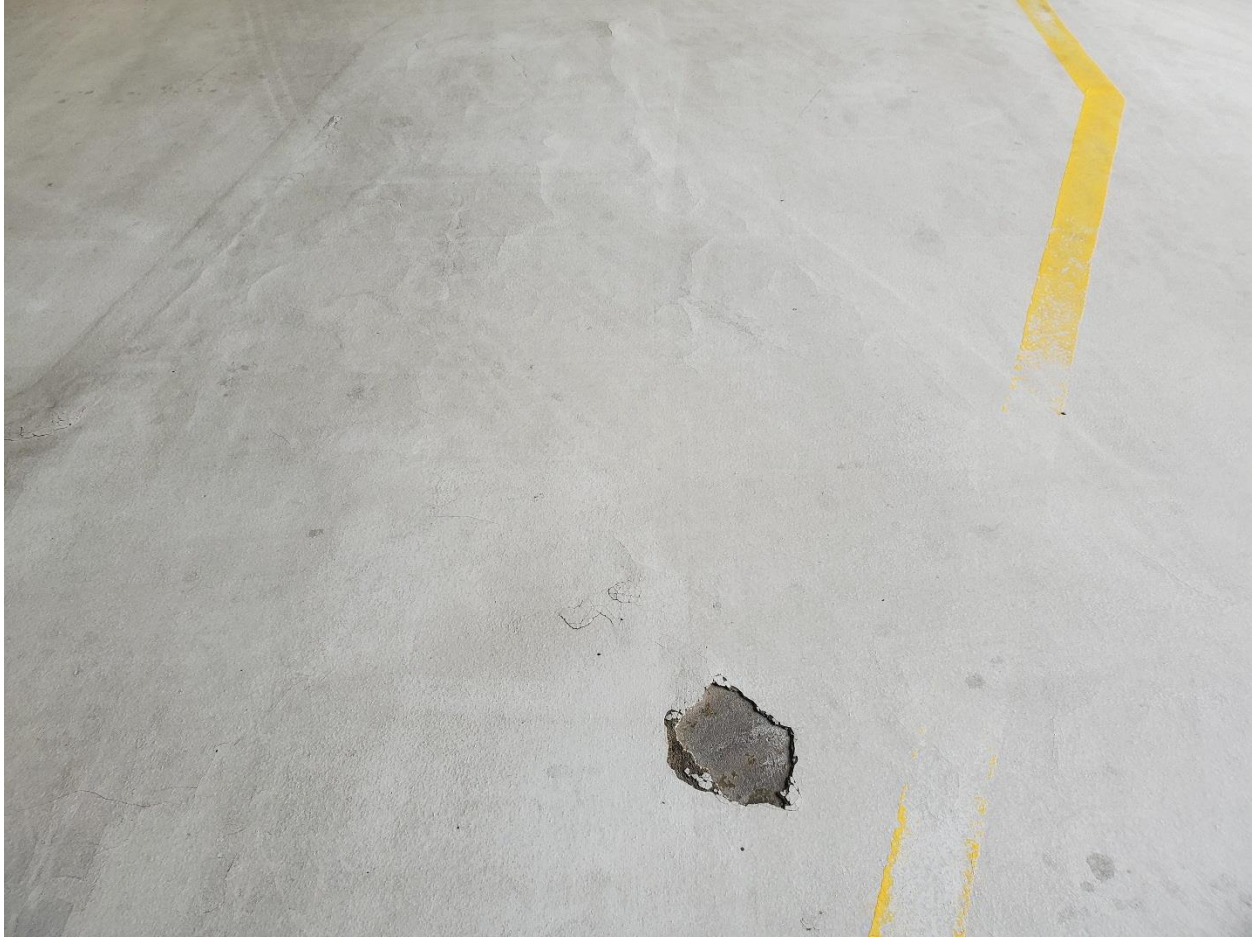
Close up on damage area

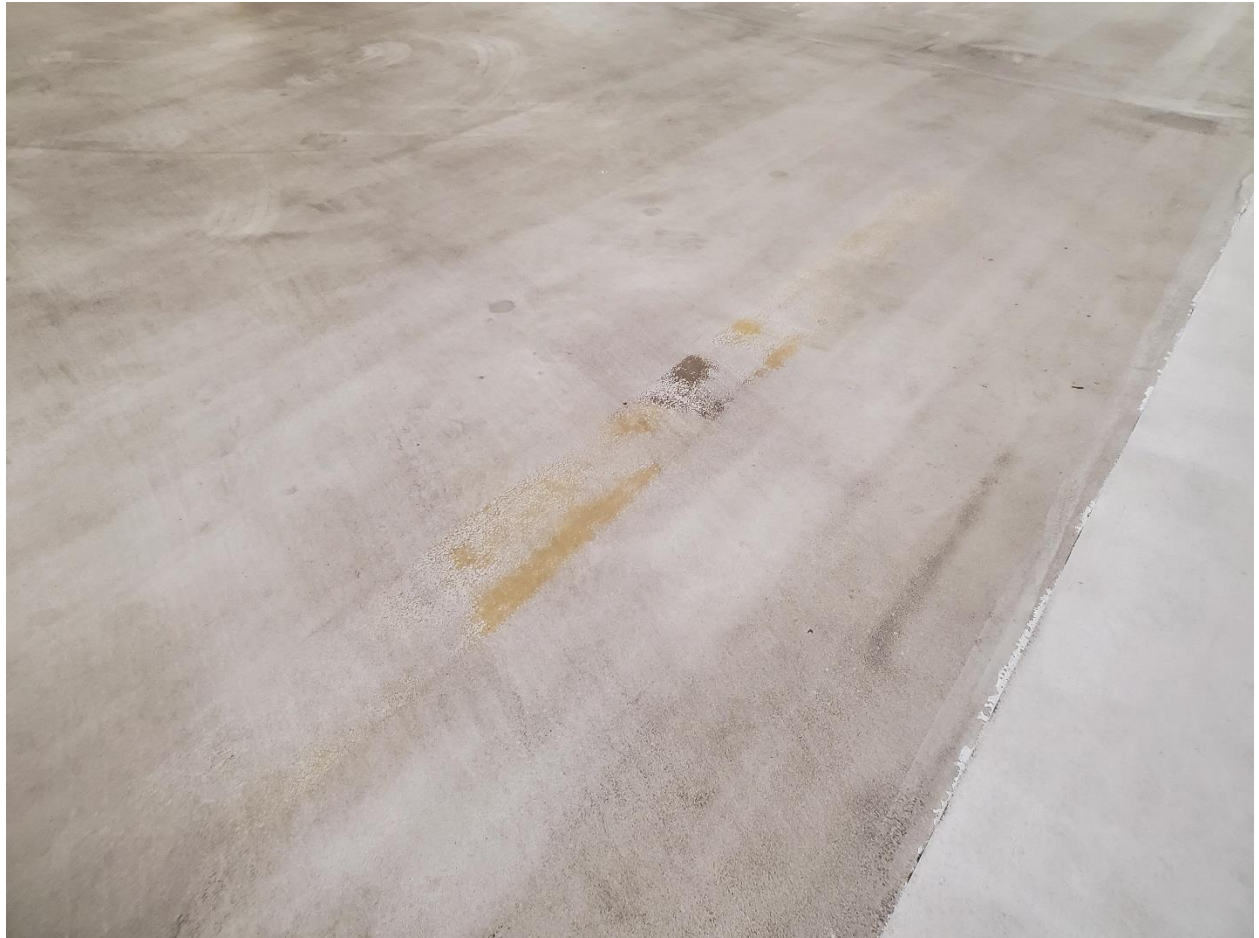
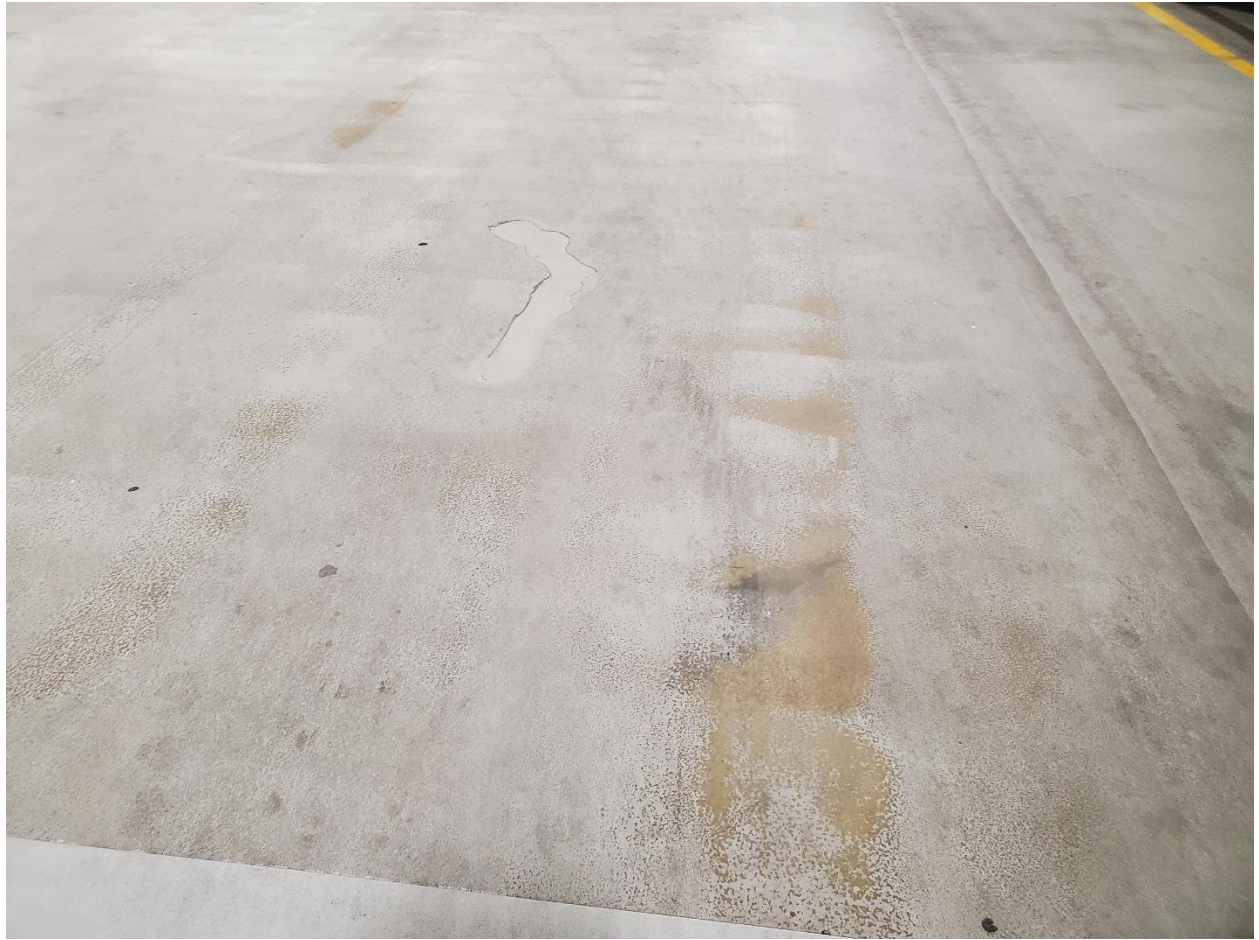
Area to be recoated at the bus entrance area

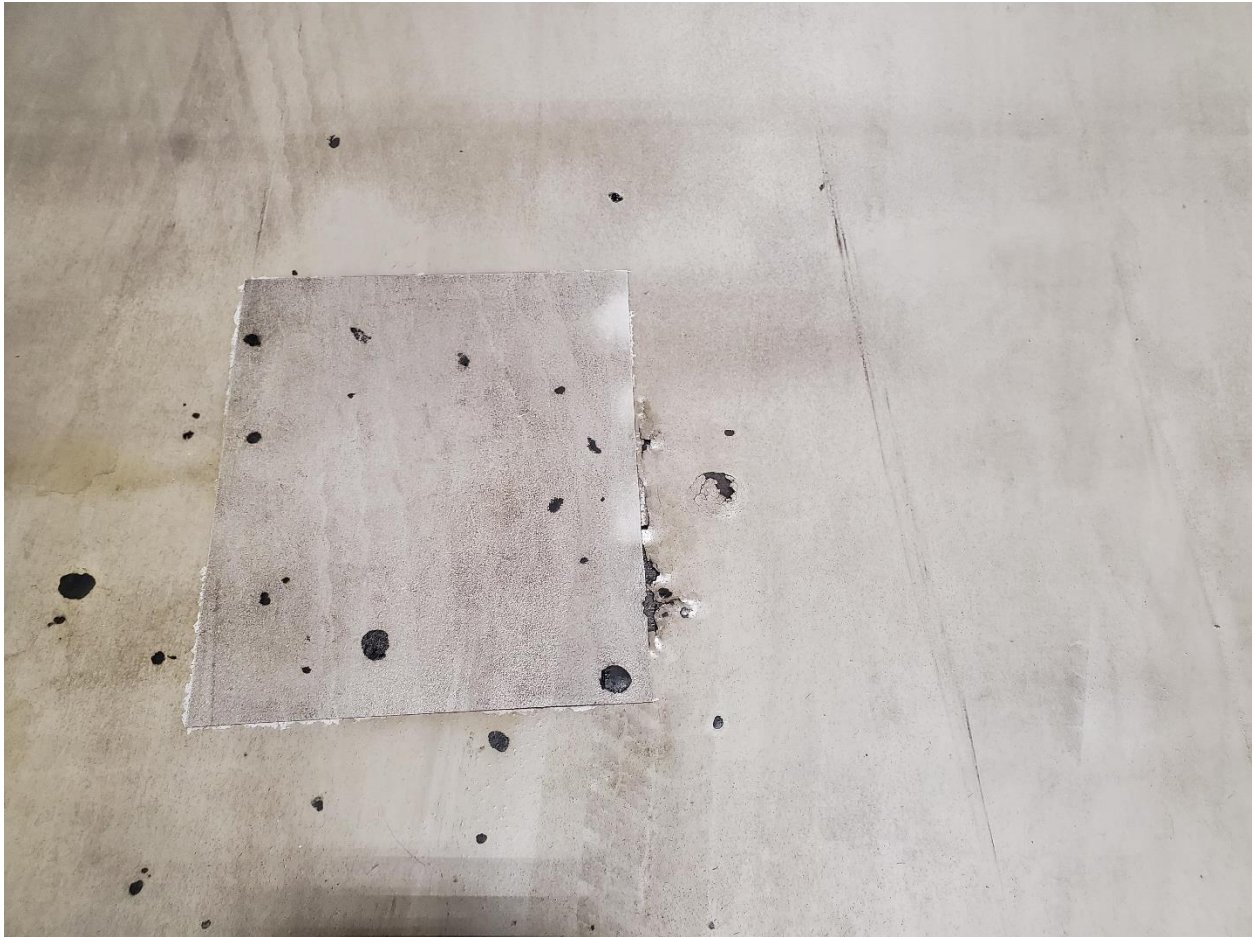
Repairs at Lane 15

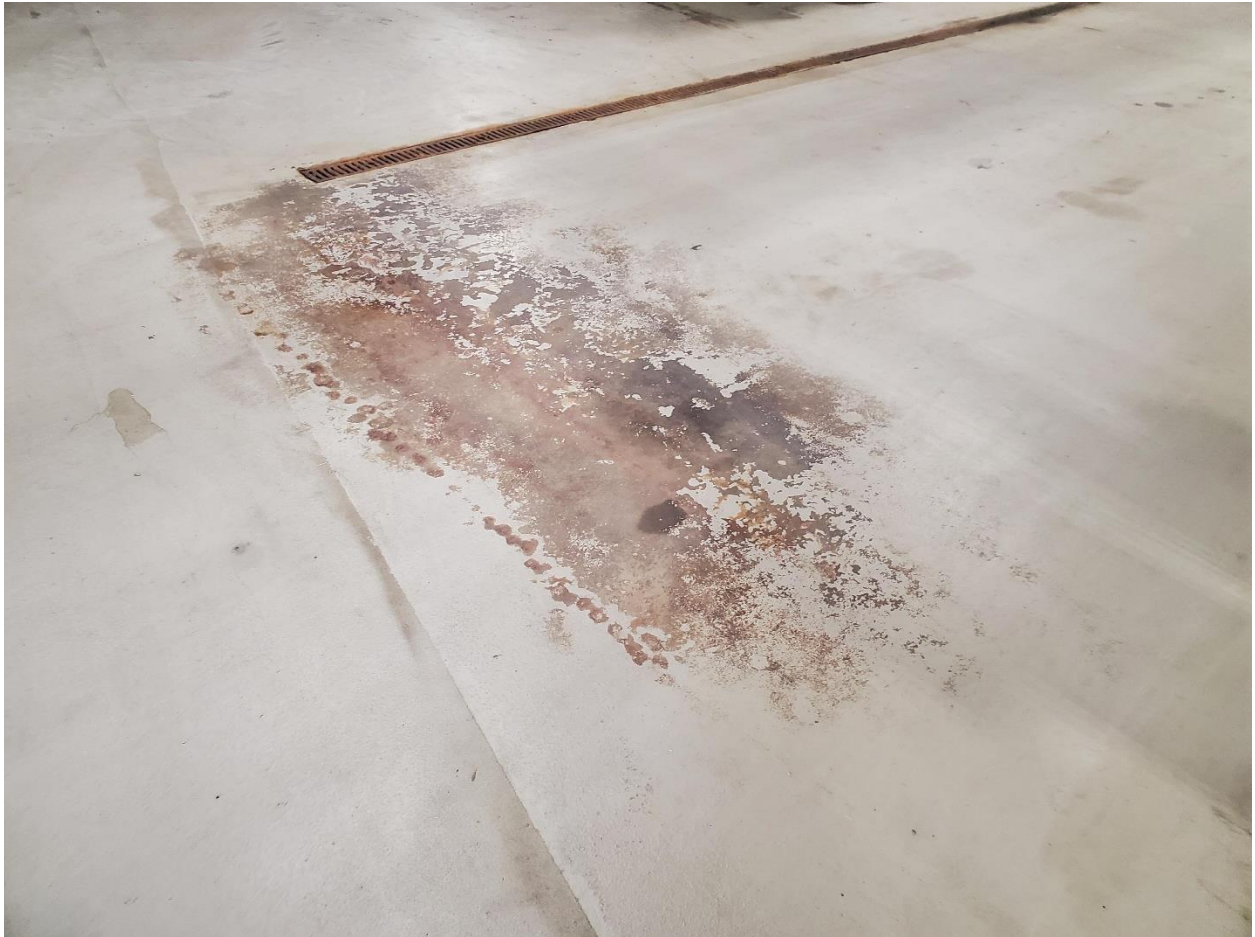
Recoating at the exit of Lane 21

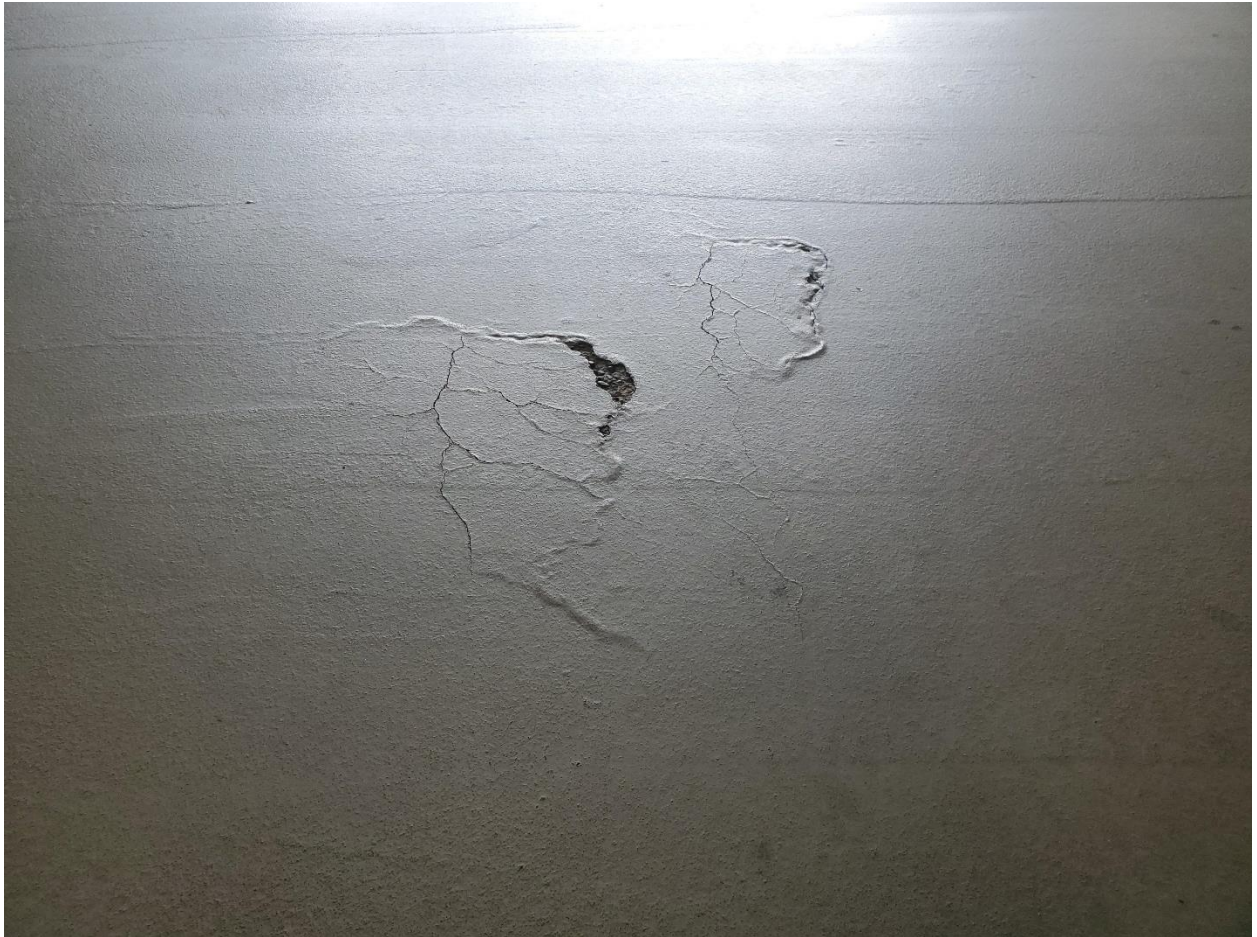
Repair at the main exit door

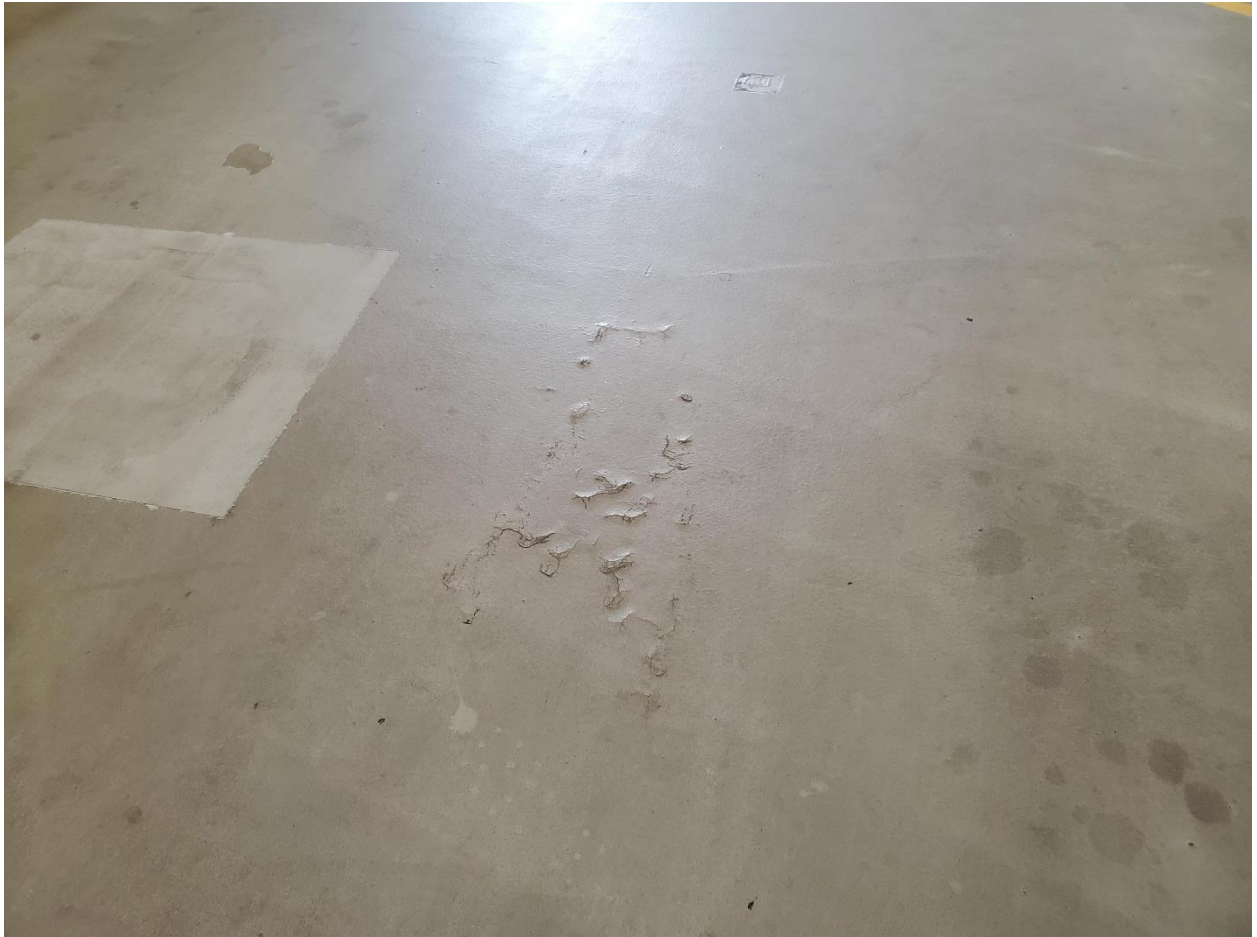
Repairs at the exit door
