Duluth Transit Authority Operation Center Facility Floor Coatings

2402 West Michigan Street Duluth, MN 55806

PROJECT TITLE SHEET

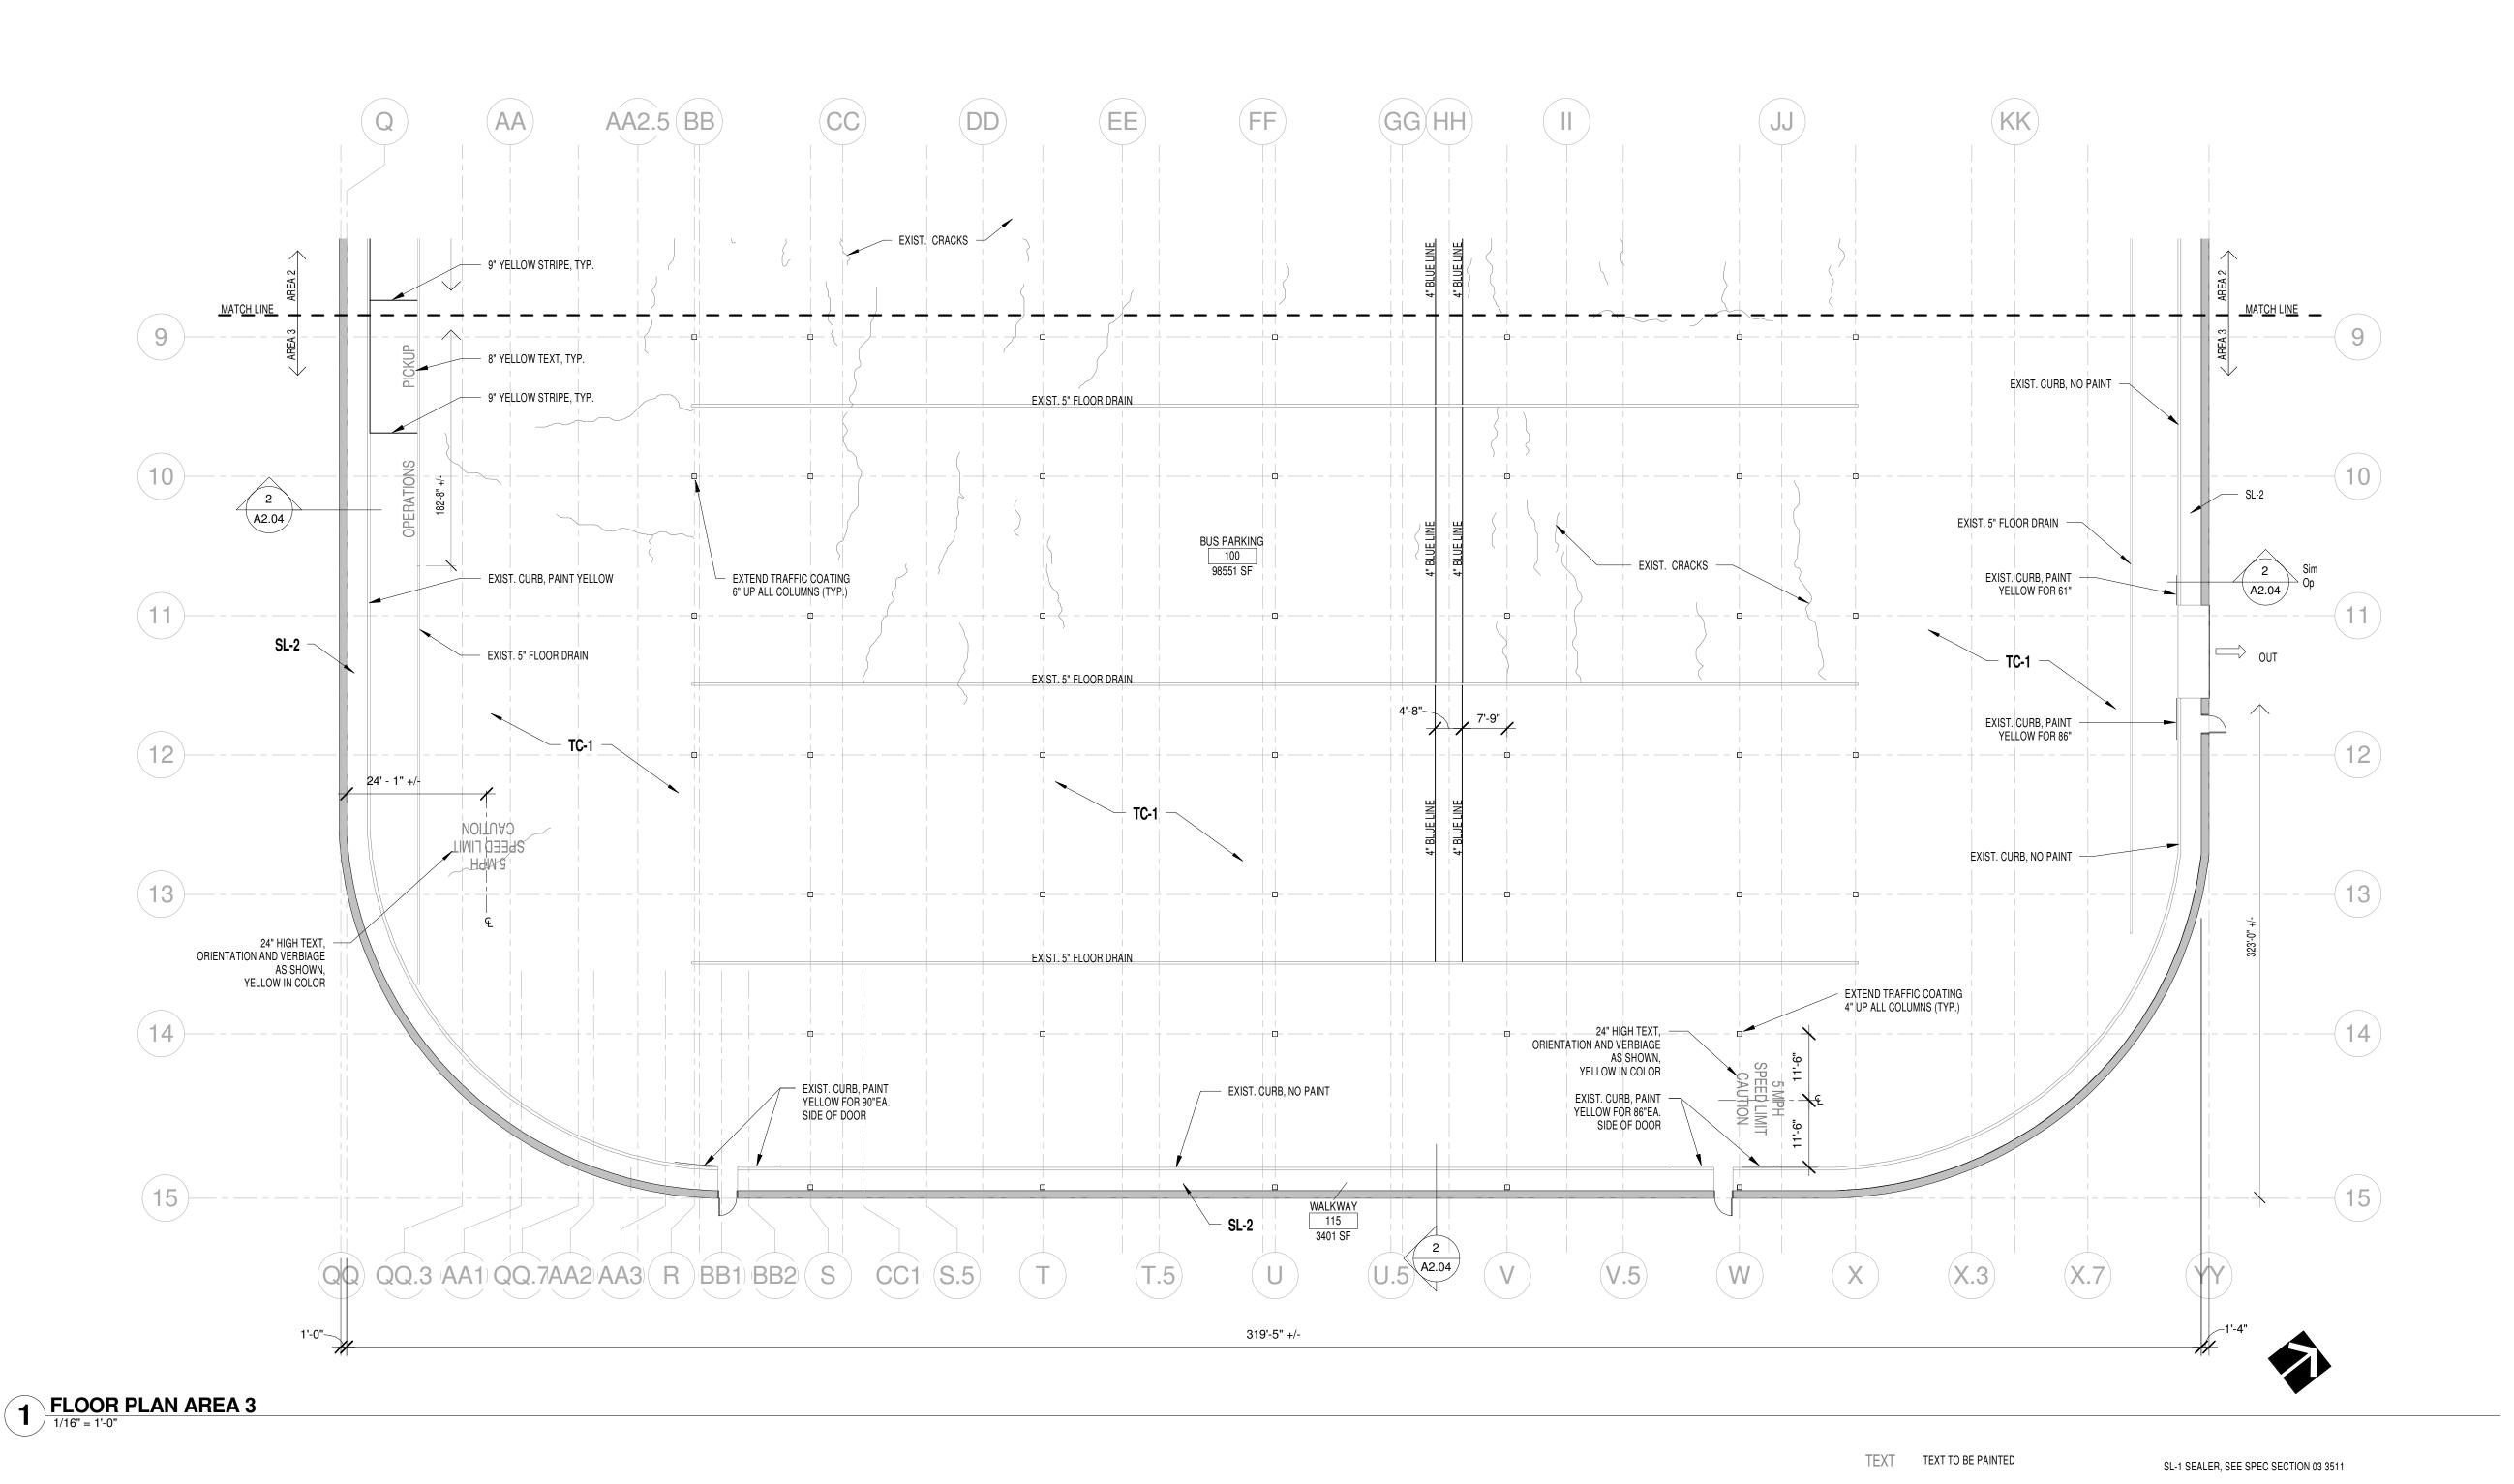
DRAWING TITLE: FLOOR PLAN AREA 3

NOTES FOR CONSTRUCTION, NOT TO BE PAINTED

NOTE: UNLESS NOTED OTHERWISE ALL PAINTED LINES ARE 4" WIDE AND YELLOW IN COLOR

EXIST. CRACK IN CONC. FLOOR
